Manhole Inspection Summary

Manhole # S11EE1001MH

Insp Date: **7/10/08 8:25 AM**

Location Address: **4001 BAREVA RD**

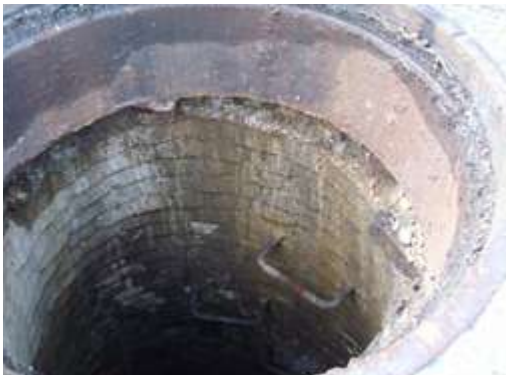
Defect 3

Offset: **3** (in.)

FRAME OFFSET

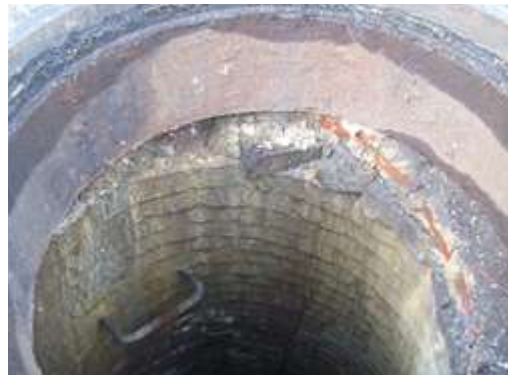
Defect 2

offset frame

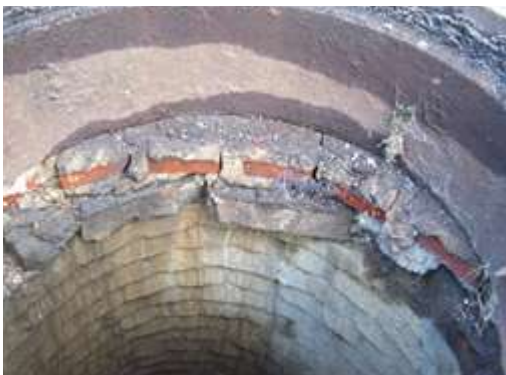
Defect 1

Infiltration: ☐ None ☐ Joint ☐ Cracks ☐ Mortar ☐ Roots ☒ **Wall**

frame infiltration
